Intel® Xeon™ Processor

Specification Update

Document Number: 249678-038

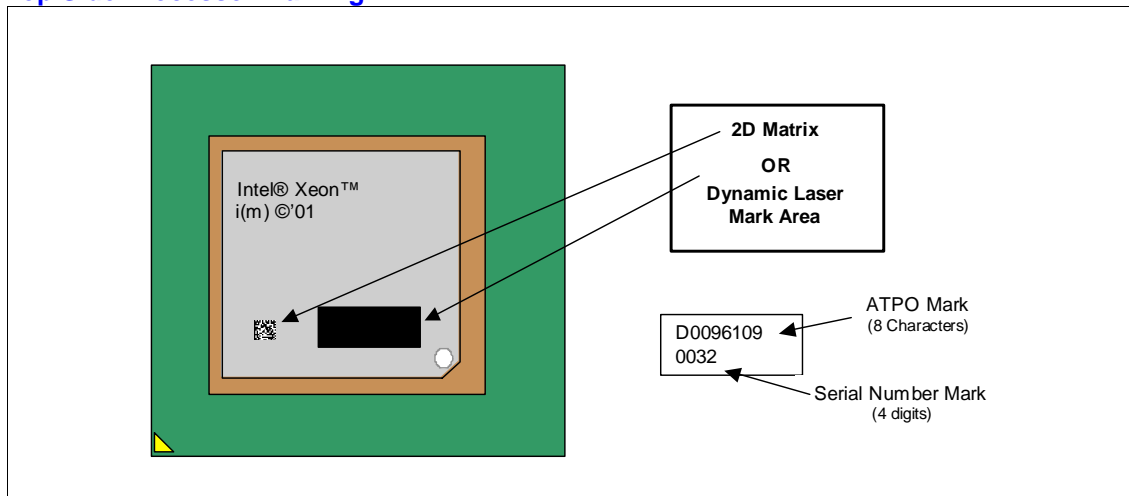
Figure 1. Top Side Processor Marking

Intel® Xeon™ Processor Markings, 256-KB Cache (603-pin interposer INT-mPGA package)

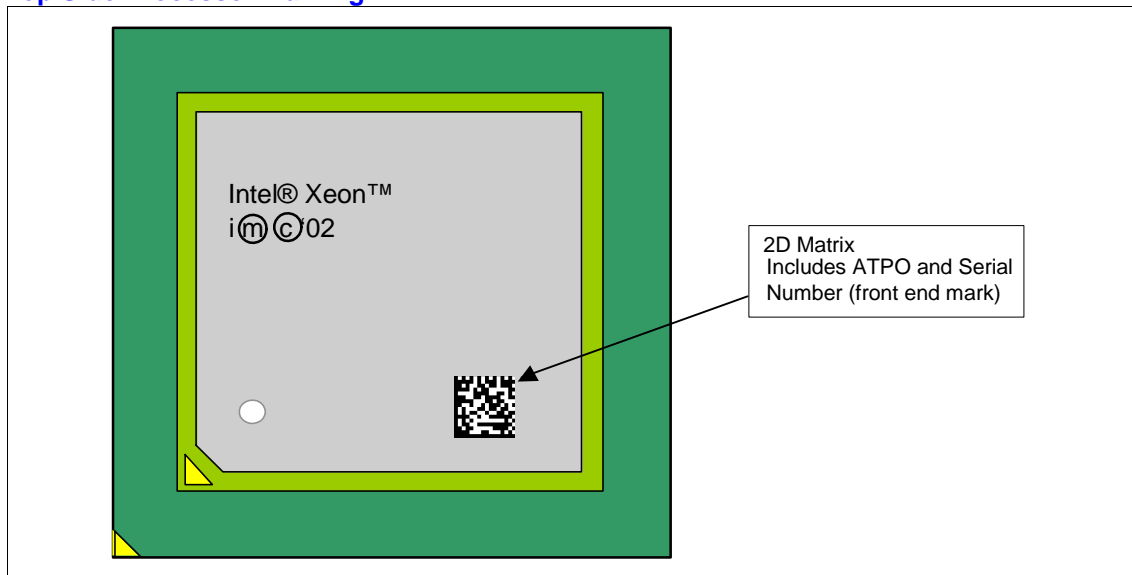
Figure 3. Top Side Processor Marking

Intel® Xeon™ Processor , 512-KB Cache, 400 and 533 MHz FSB Markings, (603-pin interposer INT-mPGA package and 604-pin Fc-mPGA2 Package)

Version	Description	Date
-001	Initial Release.	May 2001
-002	Added errata P27-P28.	June 2001
-003	Updated erratum P25.	June 2001
-004	Added RCPPS, RCPSS, RSQRTPS and RSQRTSS instruction specification clarification.	July 2001
-005	Added errata P29-P32. Added Unused outputs specification clarifications.	August 2001
-006	Added errata P33-34. Production mark update to include 2D matrix	September 2001
-007	Added 2 GHz frequency, D0 stepping and FC-BGA package information Added DP Platform Population Matrix Updated Summary of Errata table with applicable "Fixed" & "No Fix" errata plans Updated Errata P32	October 2001
-008	Added Erratum P35 Updated Summary of Errata Table with latest errata status Added Documentation Changes P1-P5	November 2001
-009	Added errata P36 and P37. Added Documentation Change P6. Updated Summary Tables with latest errata and documentation changes.	December 2001
-010	Added Documentation Changes P7-P11. Added Errata P38-P44. Added new processor with Processor Signature=0F24h B0 Step. Added new Sspec processors to Processor ID and DP Matrix tables. Added new package markings(Figs 3,4) for 512KB Cache processor.	January 2002
